BRIDGE DECK CONDITION REPORTS

Case Study

Noggin 1000 SmartChariot survey

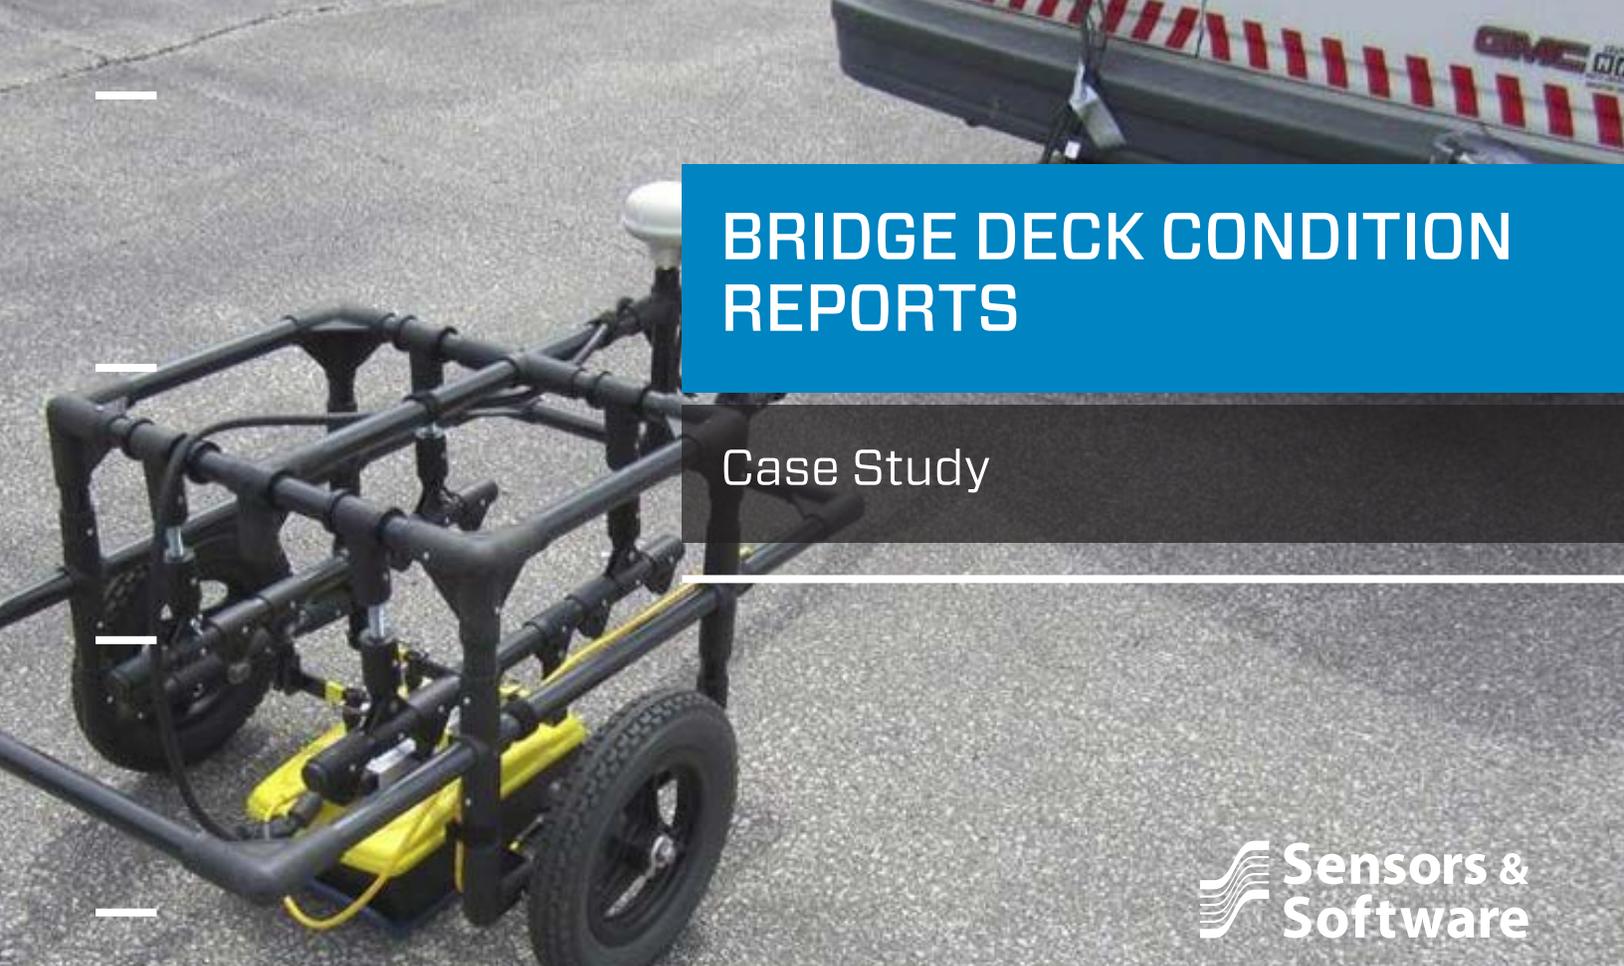
GPR data were acquired on the 3 east-bound lanes of a 90 meter long bridge using a Noggin 1000 GPR in a SmartChariot vehicle-towed configuration. Three lines were collected in each lane: in the Left Wheel Path (LWP), Right Wheel Path (RWP) and the Center (CTR). This provided 9 lines with a total of approximately 810 meters of GPR data on the bridge.

The odometer triggered data acquisition every 3 centimeters (about 1.25 inch) for a total of about 27,000 unique sample points on the bridge deck. A GPS was connected to the GPR system, enabling all data to be accurately geo-referenced. The positions of the survey lines are displayed in the following Google Earth image.

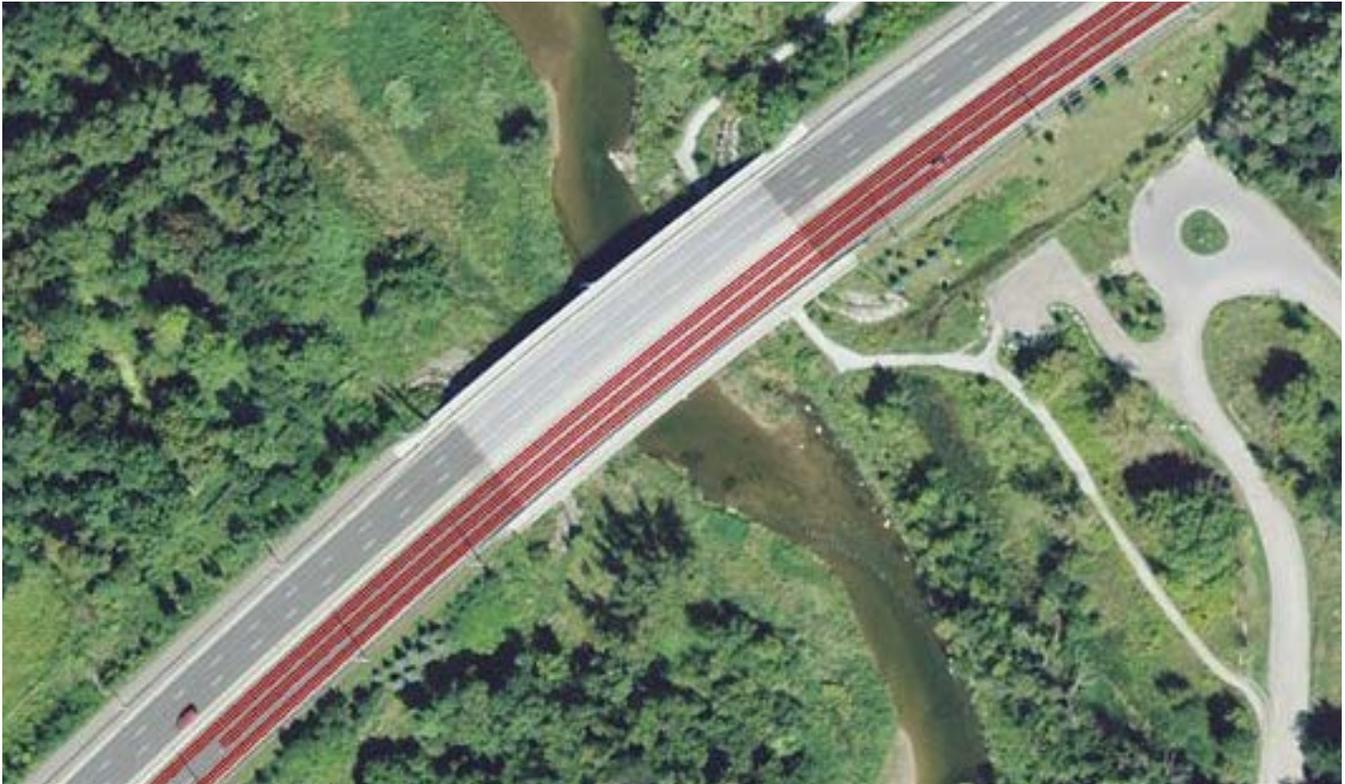
Bridge survey lines

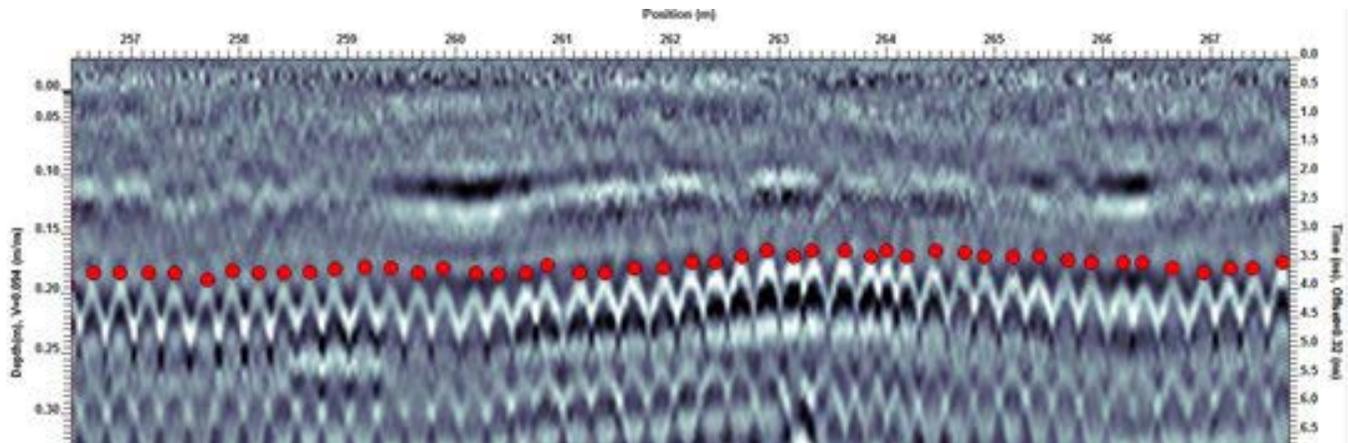
A cross-section of a portion of one line is shown below. The data show that the rebar spacing on the bridge deck is 25 centimeters (approximately 10 inches).

100 meter long GPR line showing picked rebar (red dots).

Using the EKKO_Project interpretation module, the hyperbolic responses from the rebar were picked – the Smart Point feature was used to pick the best position of each rebar (red dots).

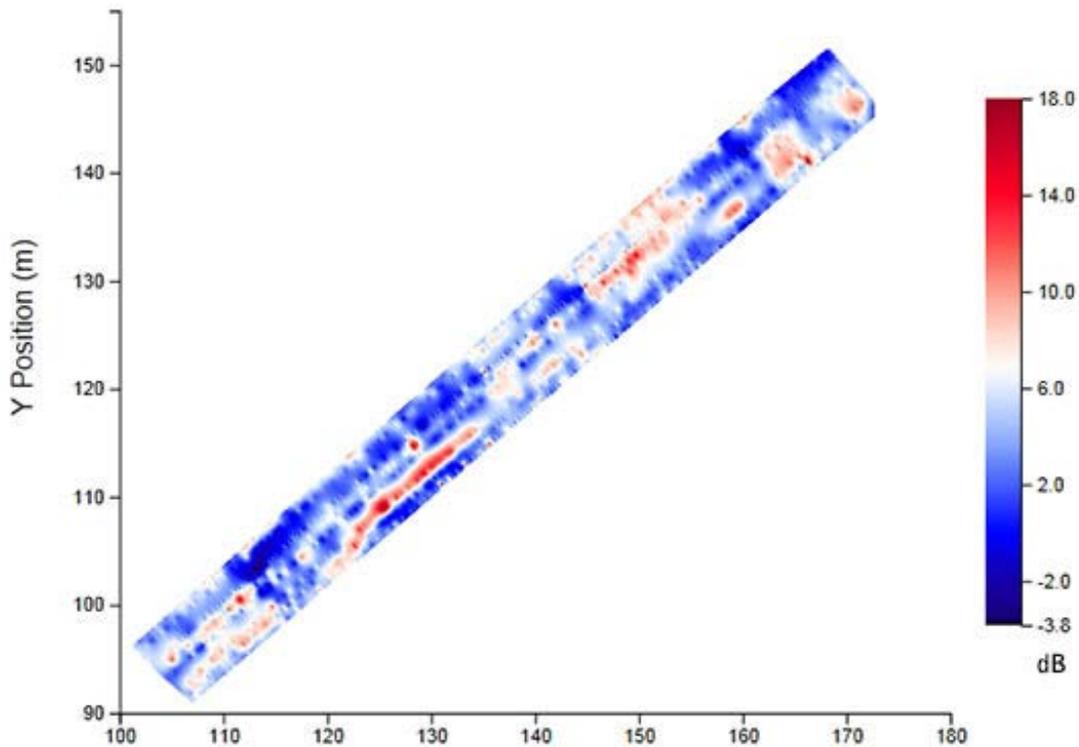
amplitude values and create signal attenuation map images. Two types of Response Amplitude displays are available; raw amplitude yields GPR signal strength in millivolts (mV) while a normalized display presents the data in decibels (dB). The latter map is often referred to as a Deterioration Index map. The 'dB' map uses an enhanced version of the processing outlined in ASTM standard 6087 for GPR data on asphalt-covered bridge decks.

Rebar Response Amplitude Map. Higher values (red) indicate areas of higher attenuation which may indicate bridge deck deterioration due to saline intrusion and rebar corrosion.

The EKKO_Project map image provides the option to change the Color Palette and amplitude range.

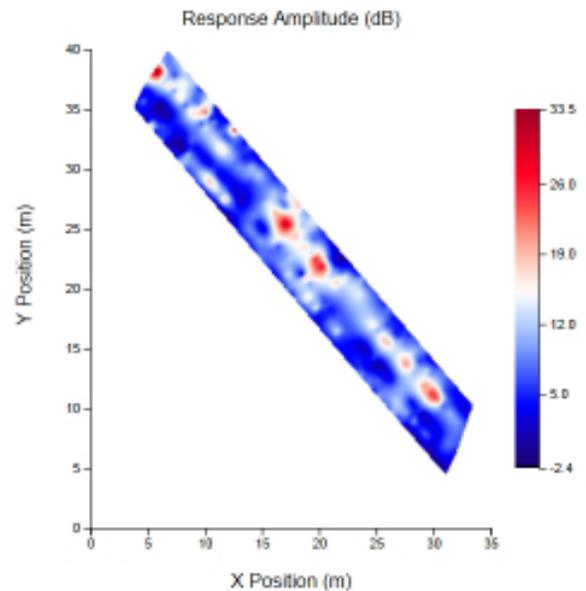
Bridge Deck Amplitude Image:

The EKKO_Project Bridge Deck Condition Report module outputs the map image in a report format with several fields for the GPR operator to fill in including the survey location, number of lanes and the GPR system used (see image below). The report can then be printed directly or to a PDF document.

Example of an automated report created from EKKO_Project as a pdf document that is easy to share.
